**A PARCEL PROPERTY LAND AND  
BUILT ON DWELLING, SITUATED AT  
CAYA G.F. (BETICO) CROES 161**

**“DRIVE BY” APPRAISAL REPORT 2026\_212**

**APRIL 30, 2026**

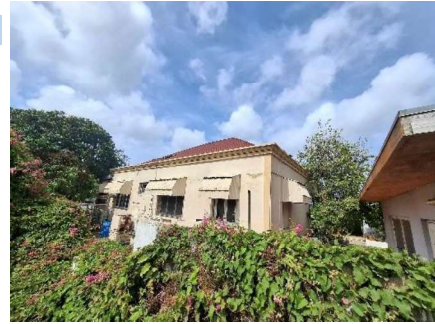
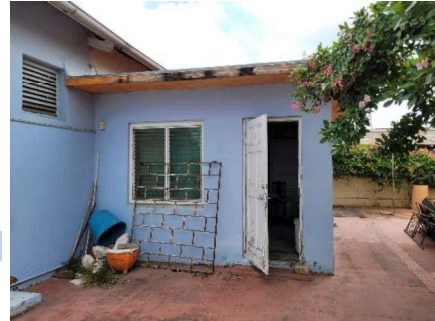
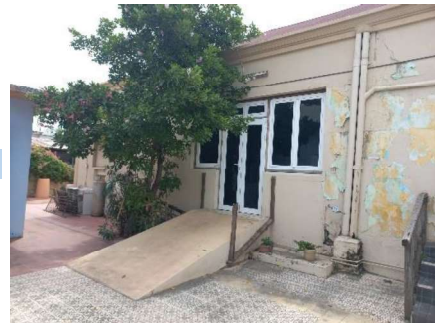
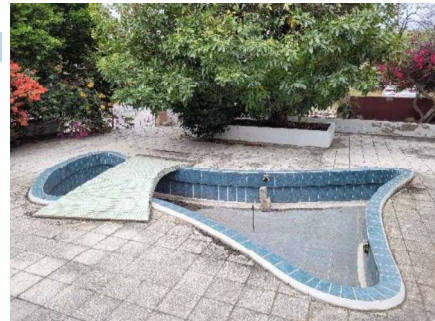
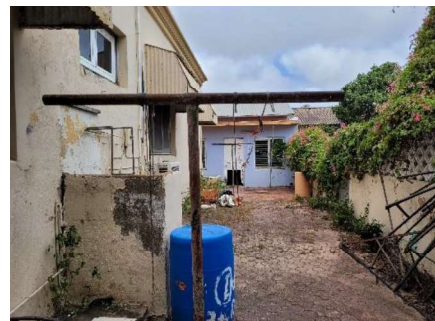
- The premises were inspected externally only, based on visible and accessible components
- The dwellings show many visible defects and the overall condition of maintenance is moderate to insufficient
- No complete interior inspection was conducted during the present appraisal assignment
- Based on visible observations, the overall condition of maintenance of the dwellings appears moderate to insufficient, showing several visible defects
- Few visible defects are considered regular maintenance items to be addressed within 2 years

MAINTENANCE TABLE	N	G	S	M	I	P	U	Clarification
Foundation			X					
Floors			X	X				Floor sagged
Walls				X				Several cracks in walls around the dwelling
Roof				X	X			Several areas of the roof is damaged Inspection roof structure recommended!
Frames, windows and doors			X	X				Glass shutters at the exterior & interior doors missing
Floor and wall tiles			X	X				Loose wall tiles
Ceiling				X	X			Ceiling damaged
Painting				X	X			Exterior and interior walls, face board, fence wall
Kitchen			X					
Bathroom fixtures			X	X				Cracked countertop on vanity
Plumbing				X				Further inspection and possible repair/replacement recommended
Electrical installation				X				Further inspection and possible repair/replacement recommended
Hardscape and/or landscaping			X	X				Tiled concrete floor sagged
Fencing				X	X		X	Cracks in fence walls and columns Several areas of fence walls require reconstruction
<p><i>N: new (within 1 year after completion)</i>  <i>G: good = as new</i>  <i>S: sufficient = no maintenance excepted within 2 years</i>  <i>M: moderate = maintenance excepted within 2 years (clarification)</i>  <i>I: insufficient = maintenance / repair necessary (clarification)</i>  <i>P: poor = replacement necessary (clarification)</i>  <i>U: unfinished</i></p>

MAINTENANCE TABLE	N	G	S	M	I	P	U	Clarification
Foundation			X					
Floors			X					
Walls			X	X				Several cracks in walls around the dwelling
Roof			X					
Frames, windows and doors				X	X			Most wooden frames, doors and windows rotten Exterior door at the toilet and laundry damaged Several windows, doors and frames show signs of termites Glass shutters at the windows are missing
Floor and wall tiles			X	X				Cracked tiles
Ceiling			X	X				Ceiling damaged
Painting				X	X			Exterior and interior walls, exterior doors and frames and face board
Kitchen				X				
Bathroom fixtures				X	X			Toilet room is not in use
Plumbing				X				Further inspection and possible repair/replacement recommended
Electrical installation				X				Further inspection and possible repair/replacement recommended
Hardscape and/or landscaping								N/A
Fencing								N/A
<p><i>N: new (within 1 year after completion)</i>  <i>G: good = as new</i>  <i>S: sufficient = no maintenance excepted within 2 years</i>  <i>M: moderate = maintenance excepted within 2 years (clarification)</i>  <i>I: insufficient = maintenance / repair necessary (clarification)</i>  <i>P: poor = replacement necessary (clarification)</i>  <i>U: unfinished</i></p>
