**A PARCEL PROPERTY LAND AND
BUILT ON COMMERCIAL BUILDING,
SITUATED AT CAYA G.F. (BETICO)
CROES 163-A**

“DRIVE BY” APPRAISAL REPORT 2026_213

APRIL 30, 2026

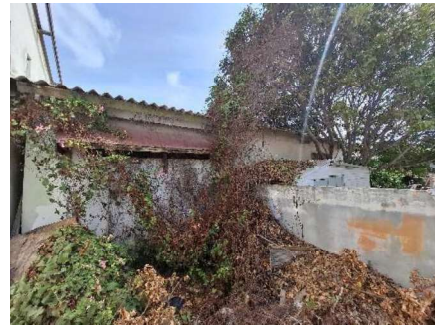
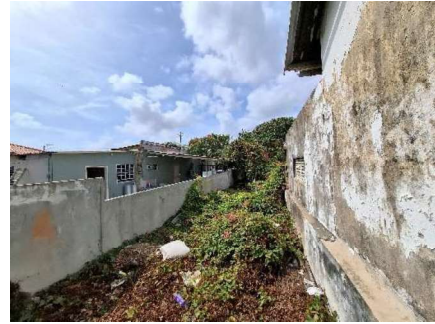
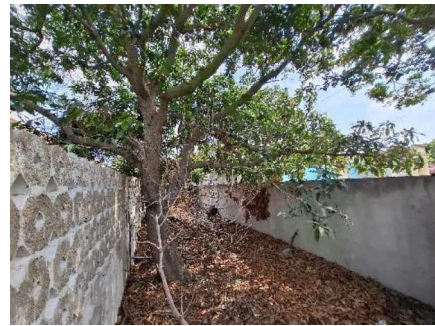
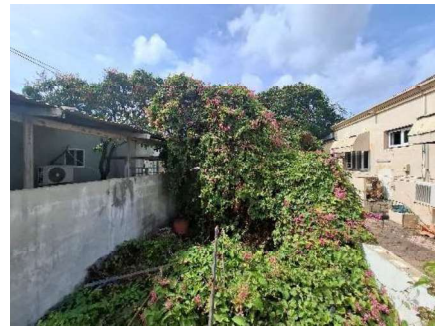
- Inspection limited to the exterior of the premises
- Several visible defects noted from the outside
- The overall exterior maintenance condition appears moderate based on visible observations
- The premises appear to be unoccupied

- Based on the exterior condition, a similar maintenance condition is assumed for the interior.
- The entrance of the building is blocked.
