**A PARCEL PROPERTY LAND AND  
BUILT ON COMMERCIAL WAREHOUSE,  
SITUATED AT NEPTUNUSSTAAT 2-A**

**“DRIVE BY” APPRAISAL REPORT 2026\_214**

**APRIL 30, 2026**

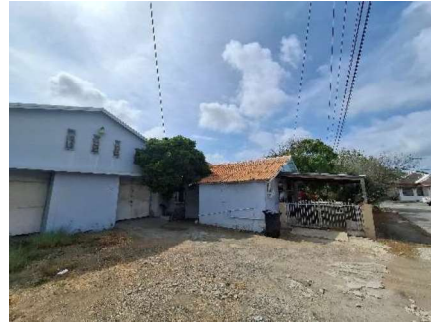
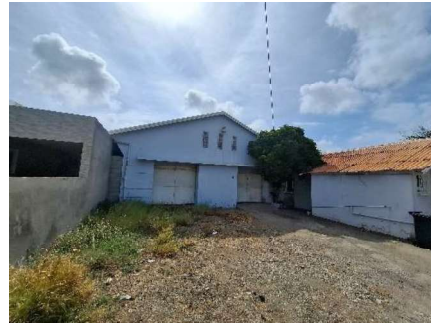
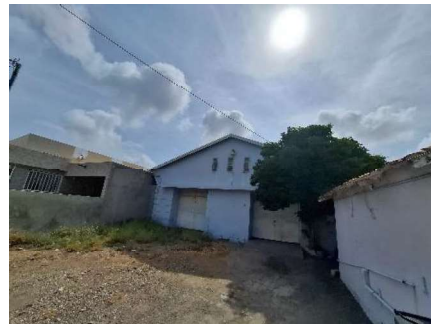
- Inspection limited to the exterior of the premises
- Several visible defects noted from the outside
- Overall exterior maintenance condition assessed as moderate  
The premises appear to be occupied based on exterior observations
